Docket No. 217 – Development and Management Plan Inspection

Northeast Utilities Service Company Certificate of Environmental Compatibility and Public Need for the construction of a 345-kV electric transmission line and reconstruction of an existing 115-kV electric transmission line between Connecticut Light and Power Company's Plumtree Substation in Bethel, through the towns of Redding, Weston, and Wilton, and to the Norwalk Substation in Norwalk, Connecticut.

Date: September 13, 2006

Location: Transition Stations: Hoyts Hill, Archers Lane, Norwalk Junction

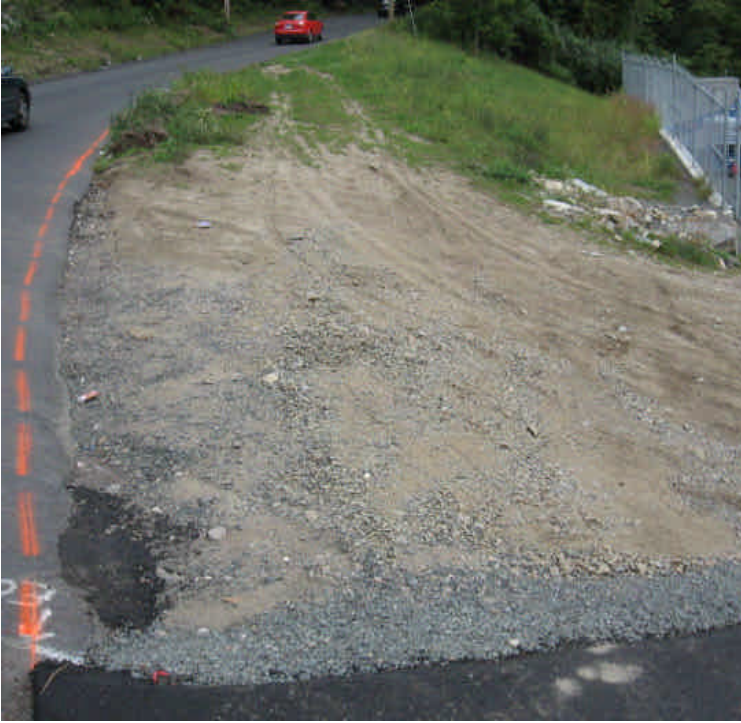
Hoyts Hill Transition Station: Photo on the left shows where curb installation will occur and the slope will be graded. Photo on the right shows an overview of the station with the tracking left by stormwater run-off on the driveway. 9/13/06

| Areas of Inspection | Observation | Recommended Action | Corrected Actions |
|---|--|---|---|
| Access Roads and Adjacent Roadways | - Hoyts Hill: Access is gained off Hoyts Hill Road. Markings are in place to pave the curb and grade the slope near the driveway. 9/13/06 | -The gully will be filled in if necessary. Asphalt curbing and grading is still proposed for the area. 8/30-9/13/06. | -N/A |

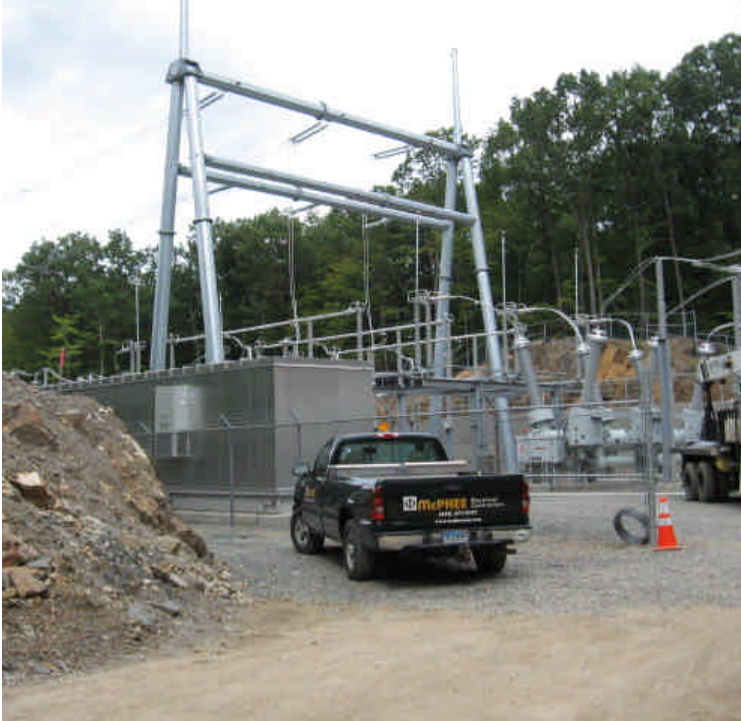
Archers Lane: Photo on the left shows an overview of the yard with the recently installed perimeter fence. Photo on the right shows a view of the screening trees that were recently planted. 9/13/06

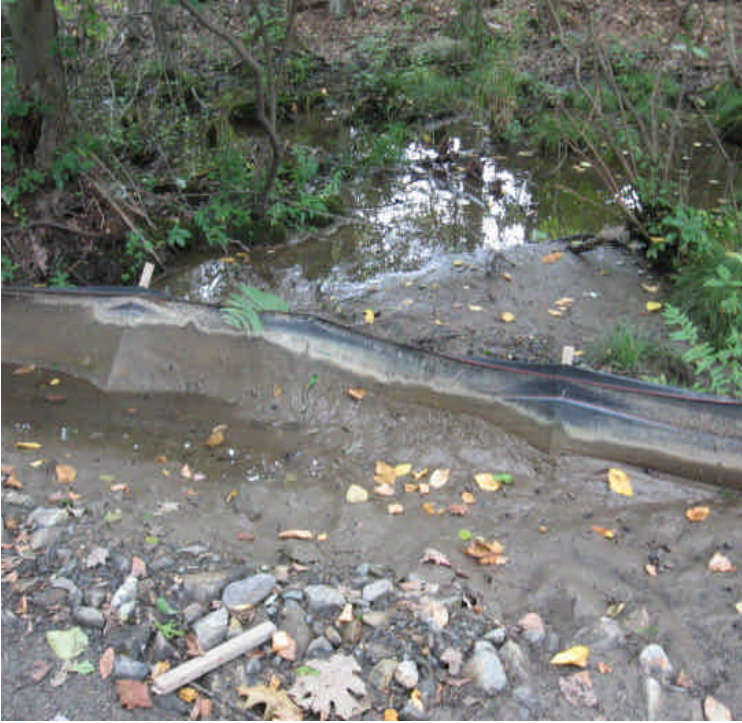
| Areas of Inspection | Observation | Recommended Action | Corrected Actions |
|---|--|---|---|
| | - The silt fence along the access road retains accumulated sediment and pooled water. 8/30-9/13/06 Significant sediment still needs to be removed from the wetland 7/26-9/13/06 | - This area will also need some final stabilization measures as this is an ongoing problem. Remove sediment carefully by hand. It is several inches deep in spots 8/9-9/13/06 | - Needs sediment removal. (Future solutions were discussed at the meeting) |

| Areas of Inspection | Observation | Recommended Action | Corrected Actions |
|---|---|---|--|
| Inland Wetland and Watercourse encroachment and mitigation | <p>- Hoyts Hill: The wetland remains well protected and well vegetated 9/13/06</p> <p>-Archers Lane:Significant accumulated sediment in the 1st wetland crossing needs to be removed. 6/28-9/13/06.</p> <p>- Norwalk Junction: The outlet of the drainage swale is at the headwall of the wetland area. Wetland vegetation was growing but silt has accumulated and turbid water remains 6/14-9/13/06</p> | <p>-Erosion controls could likely be removed from most areas. 9/13/06.</p> <p>- Carefully remove the sediment from the wetland where there are significant buildups Some areas have almost 6 inches. 6/28-9/13/06.</p> <p>- Reduce turbidity by controlling its source-disturbed surfaces and dewatering on site. Deeper sediment buildup at the outlet and within the basin should be removed. 5/25-9/13/06.</p> | <p>- N/A.</p> <p>- Still needs attention. More permanent solutions were decided at the meeting</p> <p>-Needs attention</p> |

Archers Lane: Photo on the left shows the sediment accumulation against the silt fence and within the wetland at the first wetland crossing. Norwalk Junction: Photo on the right shows the backfilled area along the perimeter fence with some stockpiles remaining. Muddy conditions have dried out. 9/13/06.

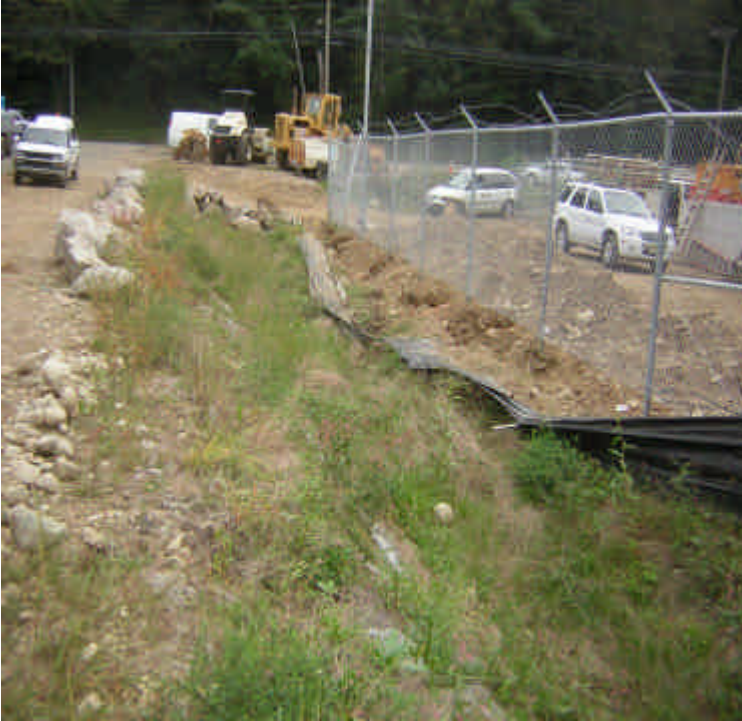
Photo on the left shows silt fence down along the swale as the area along the fence is excavated. Photo on the right shows accumulated sediment remaining in the wetland area and at the outlet. 9/13/06.

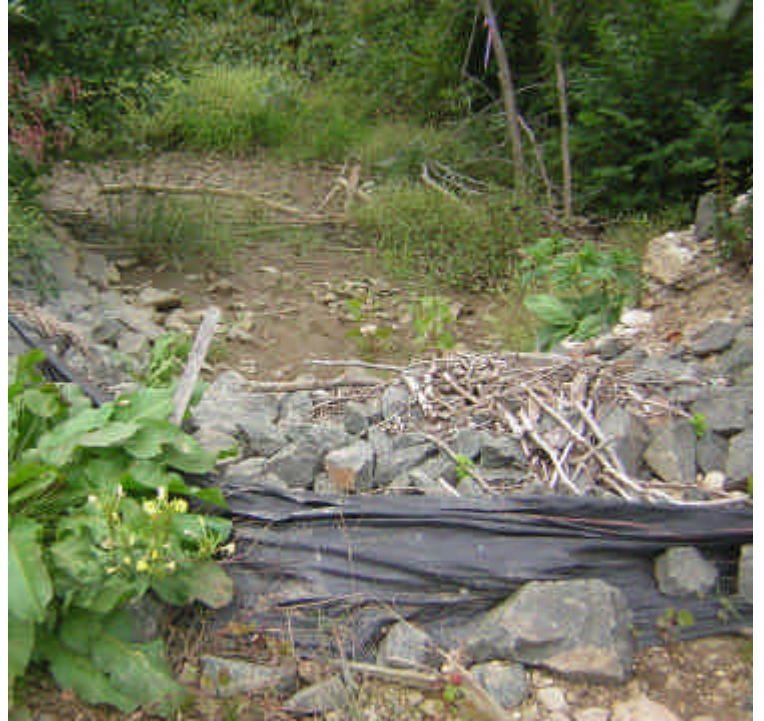
| Areas of Inspection | Observation | Recommended Action | Corrected Actions |
|---|--|--|---|
| | <ul style="list-style-type: none"> - Norwalk Junction: Perimeter silt fence remain in good shape along the river. 5/17-9/13/06. - The wetland area at the end of the swale, outside the silt fence, adjacent to the river contains accumulated sediment. 6/7-9/13/06 | <ul style="list-style-type: none"> - None at this time. Continue to monitor controls. 5/17-9/13/06. - The silt is contained and does not yet reach the river. Wetland vegetation was also noted growing here, but silt has built up significantly at the stone outlet and should be removed by hand 6/1-9/13/06 | <ul style="list-style-type: none"> - N/A - Needs attention |
